# GC-TQ Reference

Revision: A  
Released: 26-August 2011  
Author: Adam Milecki

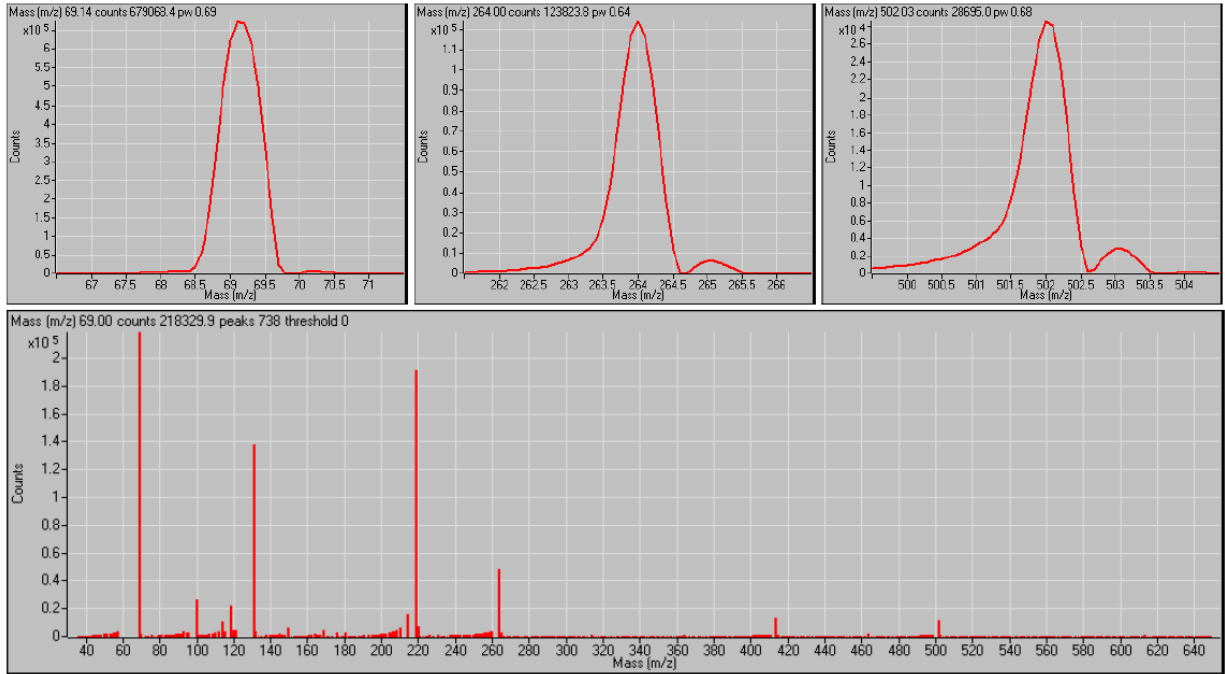
[Front Tailing on Peaks During Scan](#)

| Issue | Front tailing on peaks during scan. |

| Fix | Replace Collision Cell PCA G7000-61005. |
