**Agilent 8890GC**

**Firmware Bulletin**

**Revision 2.2.2.4**

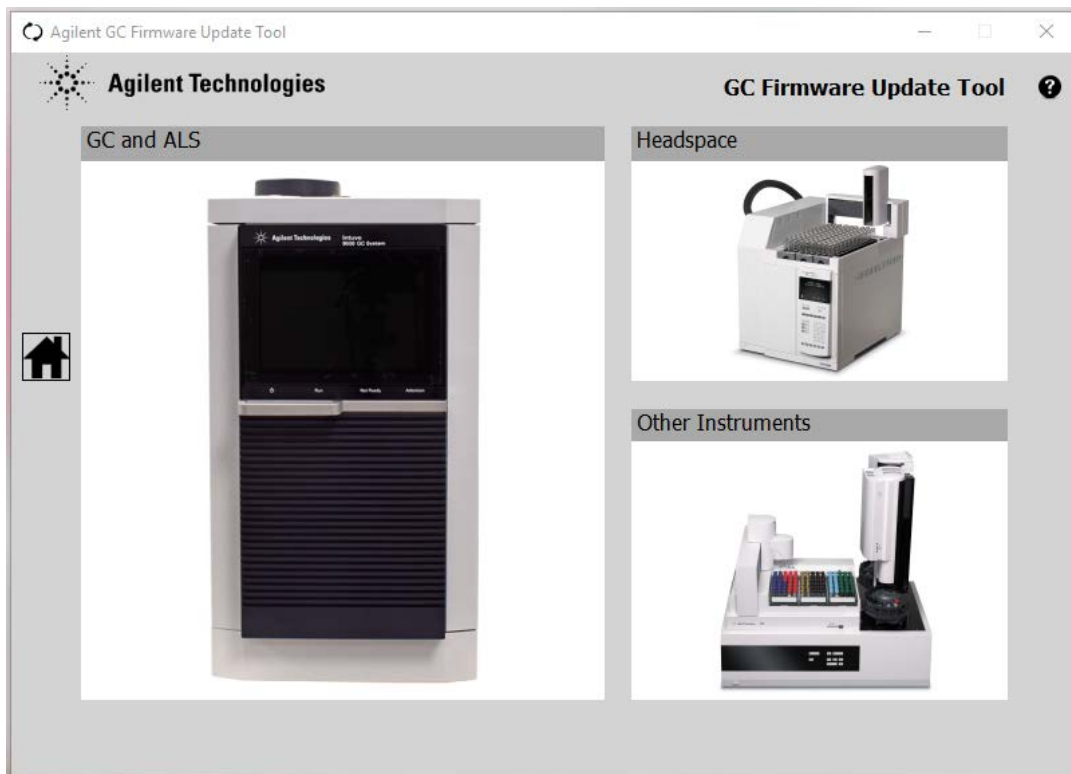
After the program has been loaded and executed the following screen appears.

This enables the user to select which instrument type needs to have its firmware downloaded. In this case we select the GC and ALS.

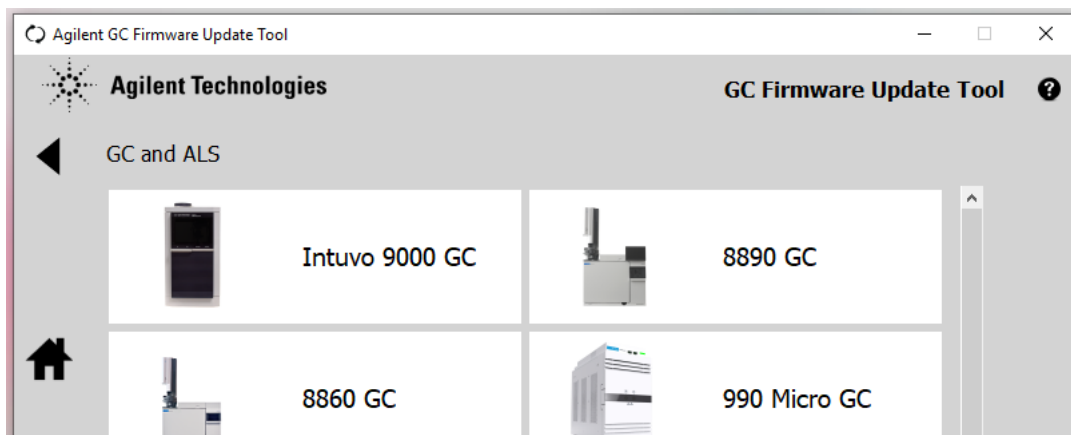
The 8890 GC is chosen from the Product menu.

The next screen allows us to either modify firmware or PID values for the EPC modules.

Firmware update is selected.

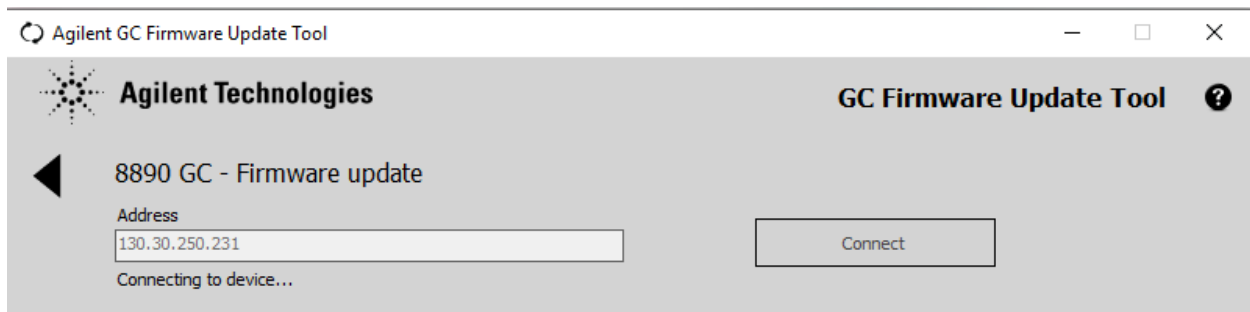
Information such as current installed firmware will then be displayed.

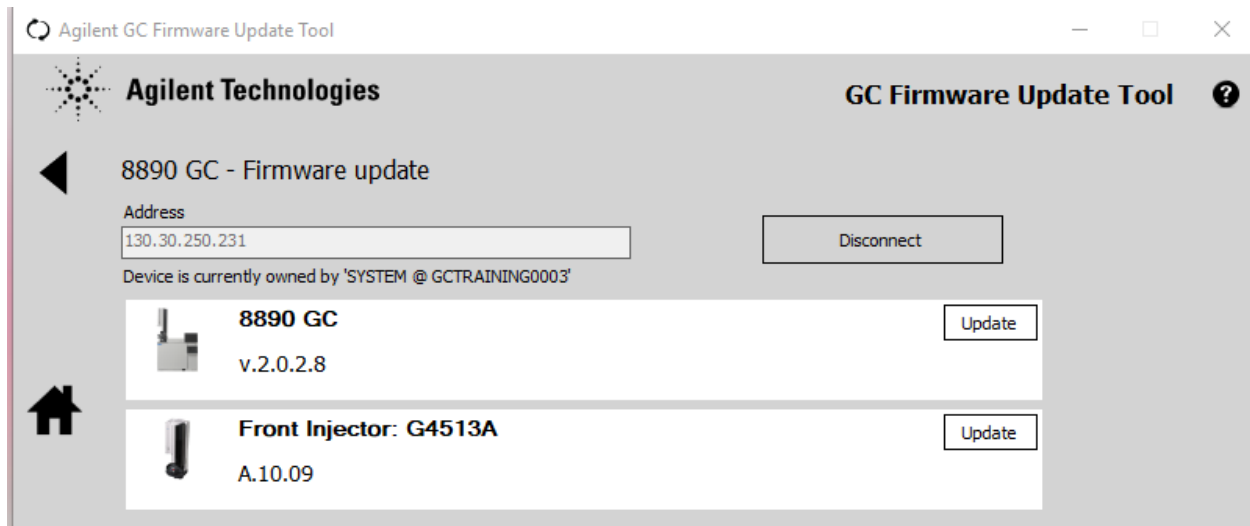
Press Update.

A Windows Explorer directory will then appear and you must select the firmware revision that needs to be downloaded.
