Application News

Observation of Joined Metal and Rubber Parts Using a Microfocus X-Ray CT System

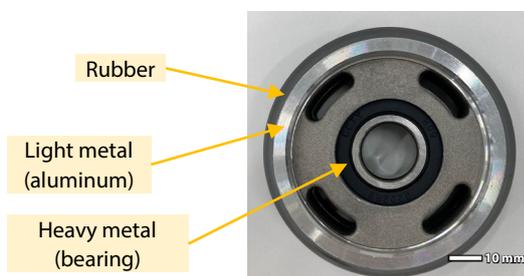
Fig. 2 Roller

In this example, the rollers were composed of a combination of heavy metal, light metal, and rubber. As shown in Fig. 2, an aluminum part is attached around the mostly steel bearing, and rubber is joined to the aluminum around its perimeter.

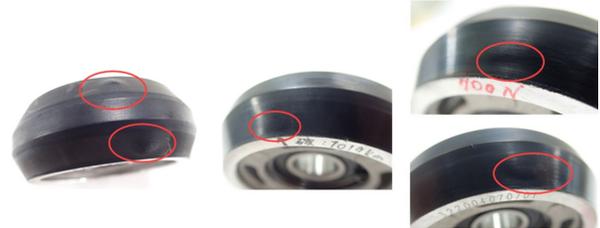
Fig. 3 Workpiece Bulges (Left: 2 Locations on Workpiece A, Center: 1 Location on Workpiece B, and Right: 2 Locations on Workpiece C)

Three types of workpieces were involved, the product that was actually being used (workpiece A) and two types of test samples (workpieces B and C). The rubber material and load test parameter settings for each workpiece are indicated in Table 1. Each workpiece had bulges (Fig. 3).

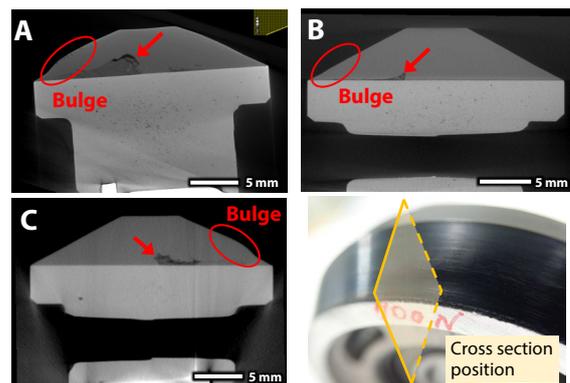
Cross-sectional images of the bulges and the position of cross-sections are shown in Fig. 4. However, only one of the two bulges is shown for workpieces A and C. In both workpieces, the areas on the interior sides of the bulges (indicated with red arrows in Fig. 4) are a darker gray than the rest of the rubber. In the cross-sectional images, the lower the density, the darker the color generally is. That indicates the area with bulges may have lower densities than the rest of the rubber.

Fig. 4 Cross-Sectional Images of Bulges (Upper Left: A; Upper Right: B; Lower Left: C; and Lower Right: Illustration of Cross-Section Position)

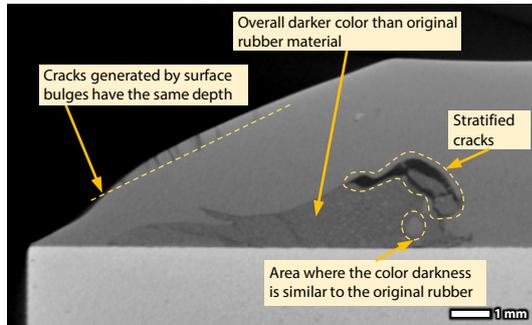
Fig. 5 Magnified View Near Bulge on Workpiece A

Fig. 5 is a magnified cross-section image inside the bulge on workpiece A. As mentioned above, the interior area of the bulge is darker than the original rubber material. This is presumably due to its lower density. One possible cause of the lower density inside the rubber is air generation, but no air bubbles or cracks are visible in Fig. 5. Therefore, it is possible that air bubbles smaller than the voxel size (indicated as 0.037 mm in Table 2) were generated. A more detailed observation of the other locations found stratified cracks and a darker color than the other rubber in the corresponding locations. This indicates that the level of deterioration varied within the area of deterioration. It also confirms that all cracks on the surface of the area of the bulge extended to about the same depth, which indicates that the level of deterioration can be observed not only in the interior but also on the exterior.

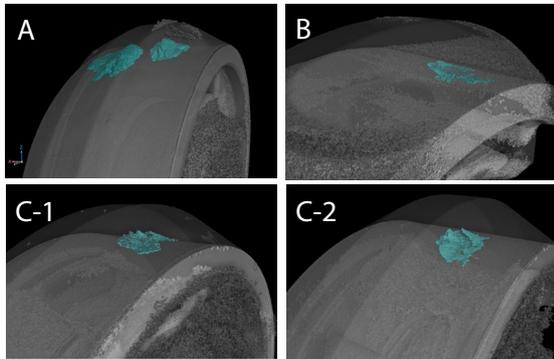
If the optional software VGSTUDIO MAX is used to color-code images, the position and shape of deterioration in the area of the bulge can be observed three-dimensionally (Fig. 6). Using the software to calculate the volume of color-coded portions resulted in the inequality $A > C > B$. A visual inspection of the roller exteriors to compare the sizes of the bulges resulted in the same $A > C > B$ relationship, which indicates a correlation between external bulges and the volume of internal deterioration. A correlation with the travel distance was also confirmed, based on a Table 1 comparison of workpieces B and C with known test parameters. In this example, CT data was compared with the visual size of external bulges, but the level of bulges could also be numerically quantified by comparing the CT data with the design (CAD) data.

Fig. 6 Color-Coded Interior of Bulge

(Bulges in C are shown in separate images due to the distance between them.)

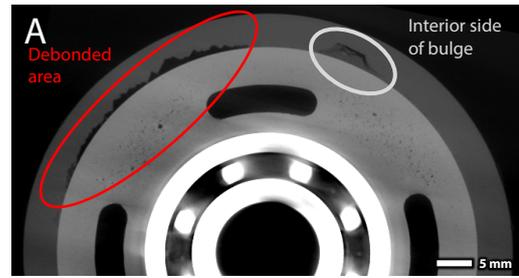
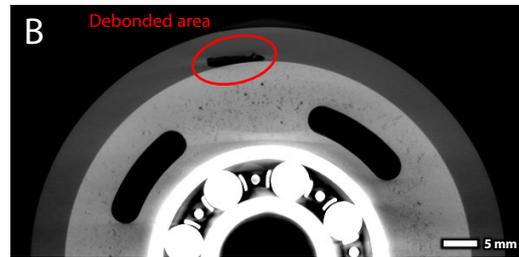
Fig. 7 Rubber Debonding

The overview cross-section images showed internal voids in areas of workpieces A and B that externally appeared normal (Fig. 7). Given the dark gray color of the interior of the bulge, the black color of the void presumably indicates rubber debonding from the metal.

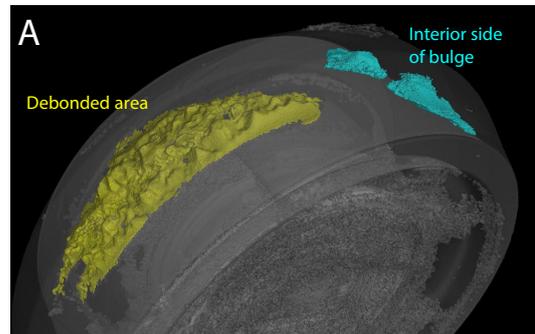
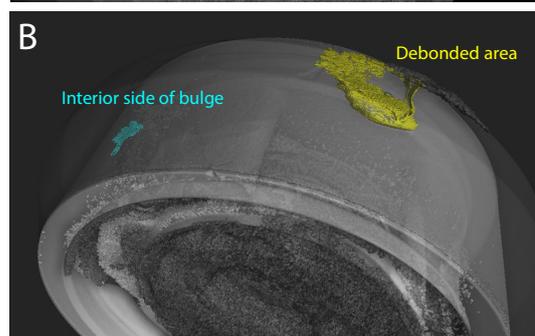
Debonded areas can be color-coded in the same manner as shown in Fig. 6 to enable observation of both internal rubber deterioration and debonding at the same time (Fig. 8). Thus, X-ray CT imaging can be used to discover internal defects even in areas without any external irregularities.

Fig. 8 Rubber Debonding (3D Color-Coded Void)
