## Analysis of Ultraviolet-Degraded Plastic by Plastic Analyzer

This article introduces an example of an analysis of a UV-degraded plastic sample utilizing Plastic Analyzer.

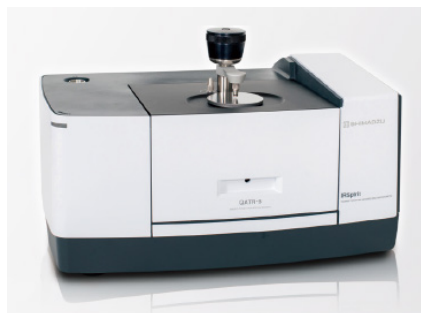
Fig. 1 Plastic Analyzer

Plastic Analyzer (Fig. 1) is a system which comprises the IRSpirit Fourier transform infrared spectrophotometer, the QATR™-S single-reflection ATR measurement accessory, and the Plastic Analyzer method package, and is an effective product for contaminants analysis and degradation analysis.

- IRSpirit Fourier transform infrared spectrophotometer
- QATR-S single-reflection ATR measurement accessory
- Plastic Analysis method package
  1. UV-damaged plastics library
  2. Thermal-damaged plastics library
  3. Dedicated program/parameters for IR Pilot™

The method package includes Shimadzu proprietary UV-damaged plastics and thermal-damaged plastics libraries, together with a macro program which provides the optimum measurement parameters. In addition, the attached analysis handbook contains the compositional formulas, infrared spectra, and characteristic peak vibration modes of 14 types of plastics.

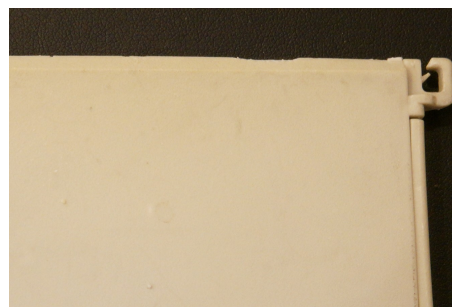
Fig. 2 Measurement Sample

A plastic part on a blind was analyzed after long-term exposure to sunlight indoors at a window. Fig. 2 shows a photograph of the measurement sample. The measurements were done using a fragment obtained by cutting out the inside of the sample (inside), a part of the sample on the indoor side that was not exposed to direct sunlight (indoor side), and a part that was estimated to have been yellowed by exposure on the window side (window side).

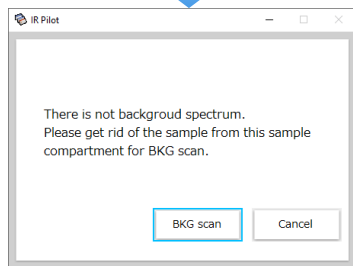
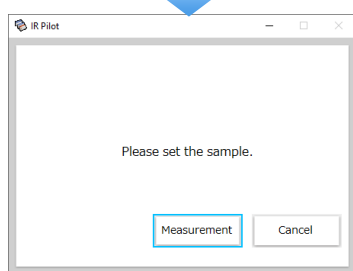
Fig. 3 Operation Workflow

The operations in this analysis were carried out using the dedicated IR Pilot macro program included in the Plastic Analyzer method package. With this program, the optimum analysis parameters for the plastic analysis are set in advance, and all operations from the actual measurement to printing the report can be carried out simply by clicking the screen. Fig. 3 shows the operation workflow.

Select the Plastic Analysis measurement program

Background measurement

Sample measurement

Spectrum search and report printout

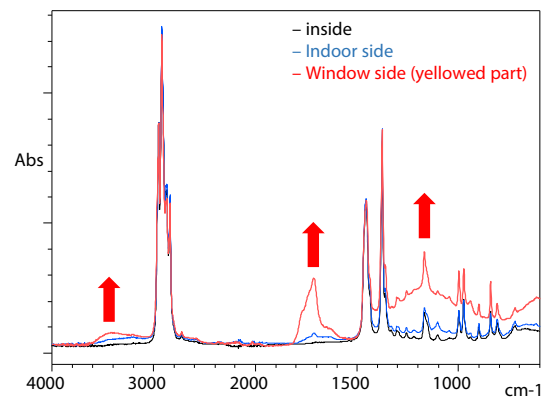
Fig. 4 Measurement Results of Sample by Plastic Analyzer

Fig. 4 shows an overlay of the IR spectra measurement results obtained by Plastic Analyzer. According to the UV-damaged plastics library, the inside of the plastic part on a blind is considered to be polypropylene (PP) which has not been exposed to UV radiation. The indoor side of the sample showed a spectrum similar to that of PP irradiated with UV for 40 hours (Fig. 5), and the window side (yellowed part) showed a spectrum similar to that of PP irradiated with UV for 125 hours (Fig. 6).

As a result of degradation by sunlight, that is, UV radiation, peaks were formed in the vicinities of  $3400\text{ cm}^{-1}$ ,  $1710\text{ cm}^{-1}$ , and  $1150\text{ cm}^{-1}$ , and these are thought to be the result of absorption associated with the O-H stretching, C=O stretching, and C-O stretching vibration due to the progress of oxidation. The surface of PP undergoes oxidative degradation as a result of exposure to UV radiation, and it was possible to estimate the degree of degradation.
